**SAS Superstructure**

Location: 04-SF-80-13.2 / 13.9

Daily Diary Report by Bid Item

Diary #: 871 Const Calendar Day: 401 Date: 10-Jul-2013 Wednesday

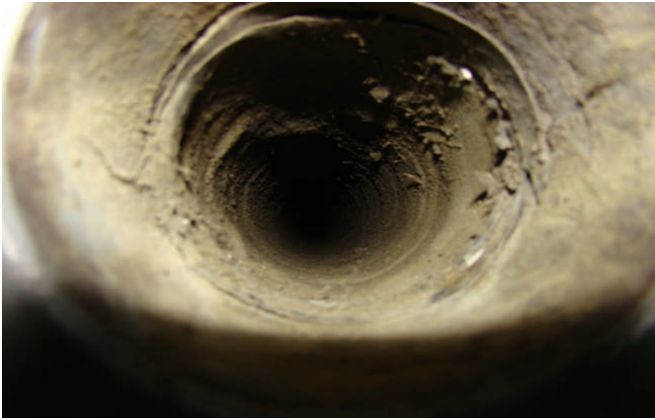
Looking down a hole where a rod was extracted at the S1 Shear Key.

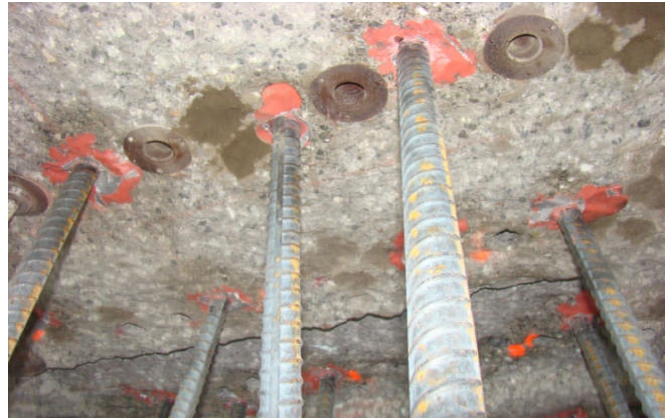
Briefly monitored ABF and Conco operations as well today while surveying and dealing with the rod issue. Conco appeared to be placing the proper amount of epoxy into the vertical drilled holes prior to placing dowels. ABF only tack welded the pipe blockouts with Nelson studs to the bearing plates. There needs to be a mortar tight seal between these two pieces of steel prior to placing SCC.

Vertical drill and bond dowels seen looking up on the far north end of the E2 cap beam using Hilti epoxy.

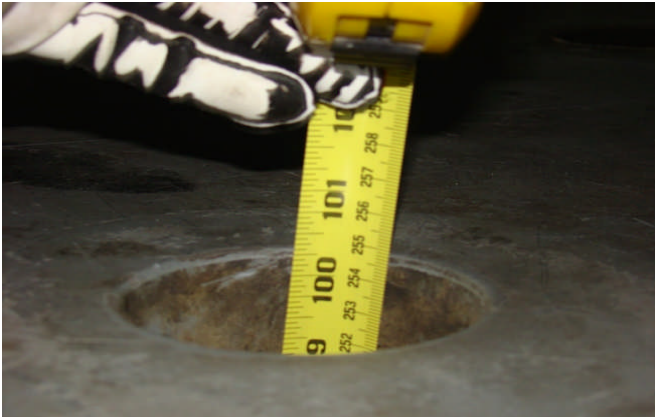
I informed Levi that the all voids need to be filled (preferably with grout) especially from the top of the extracted rods to the bottom of the 600mm replacement dowel. The reason being is that it is unknown if any water was in the holes after rods were extracted for testing. Also the replacement dowels are only being held with vertical friction between the 600mm dowel and the lower housing. Filling the void between rods would also provide vertical support ensuring that the rods wouldn't slip down the blockout hole.

Measured void distance of 2.545m for a S1 Shear Key extracted rod which will not be filled per ABF and TY-Lin.

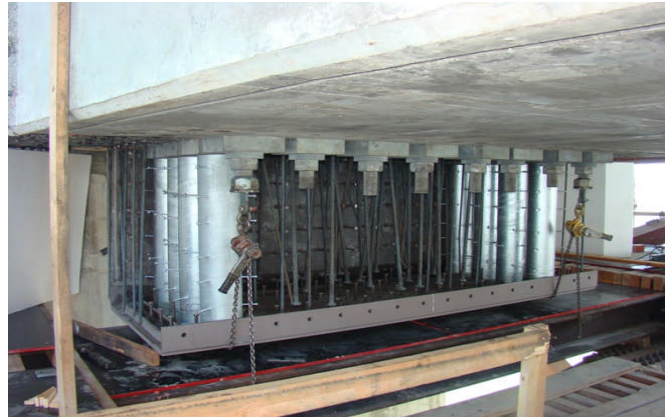
A portion of the bottom steel box beam and B3 bearing rod pipe blockout with Nelson studs installed today.

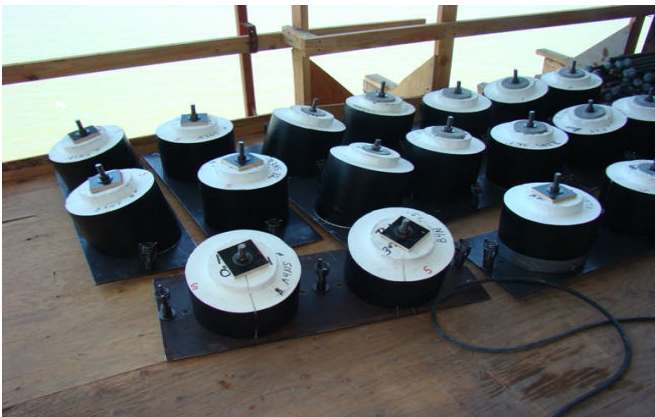
Partially constructed blockouts for the vertical tendons of the S1 Shear Key retrofit on the west side of the E2 cap beam.

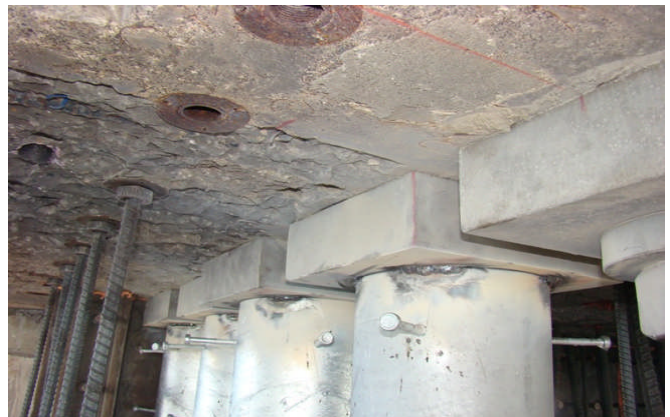
Welds on the blockout pipes to the bearing plates for the bearing anchor rods at the B1 bearing.

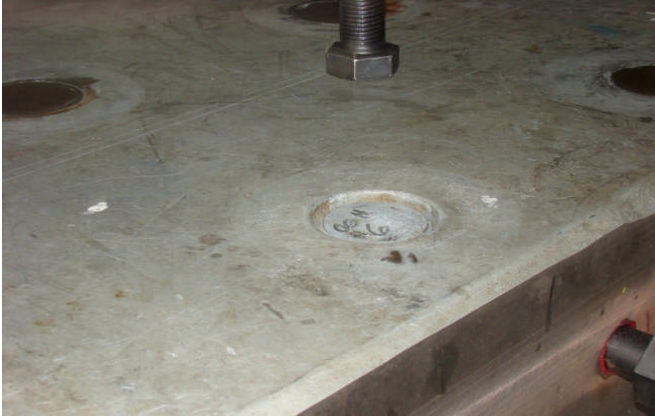
After discussing this issue Levi informed me that he wanted direction in writing. I proceeded to inform Paul Jefferson and Pamela Gagnier who in turn informed TY-Lin designers. At this time the ABF laborers hadn't placed a 600mm dowel in a blockout hole. Approximately around 2:30pm I received a call from Pamela where the direction from TY-Lin was that ABF didn't have to fill the voids between the top of the extracted rod to the bottom of the 600mm dowel. It should be noted the approximate depth of these blockout holes is 8-9ft as seen in the photo below. Only one rod was placed today without filling the void between the extracted rod and 600mm dowel.

Rod inserted into one of the S2 Shear Key holes where a rod was extracted where the void between the broken rod and new rod wasn't filled per TY-Lin.

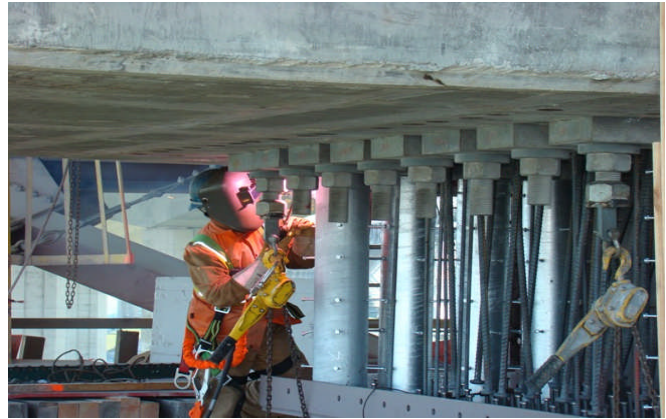
ABF welder in the process of welding a bearing blockout pipe to a bearing plate.

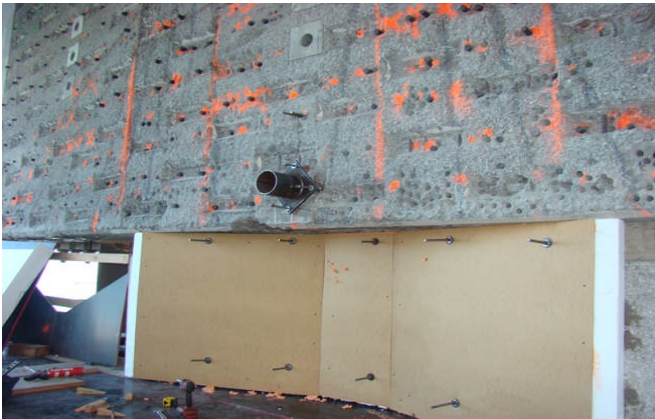
Styrofoam blockout placed against the west face of the E2 cap beam and pipe blockout for the bottom cored hole at the S1 Shear Key.

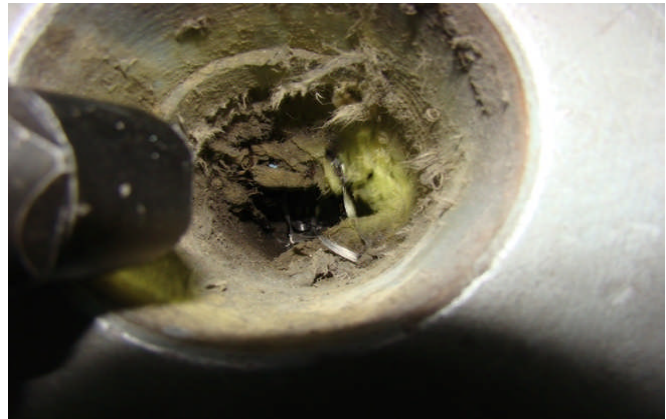
Denso tape and paste debris found in a blockout hole blocking a clear path, however the debris path can be broken to enable a filler substance.

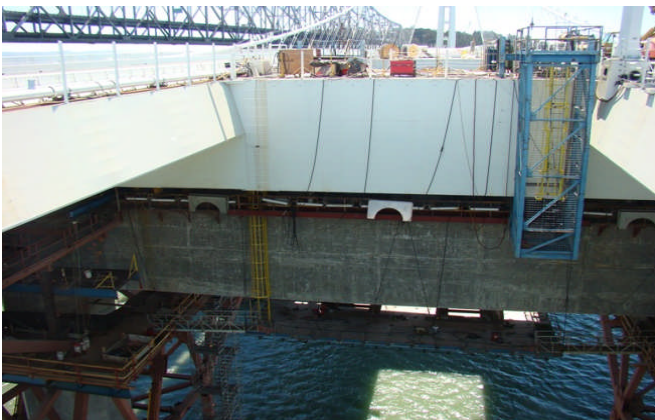
Shear Key dust covers seen placed on the handrail of the E2 cap beam from crossbeam 19.
